No.: P2020092702

Test report

Product(Sample)	eArc module
Application Dept.	Production department
Applicant	Xiaowen Liu
Test Company	<u>SUNMAN(ZHENJIANG) CO.,LTD.</u>
Test Date	2021-11-12
Tester	 
Auditor	 
Approved by	 
Date of issue	2021-12-24

To confirm the effect of eArc module's upper film creases on aging and long-term reliable performance.

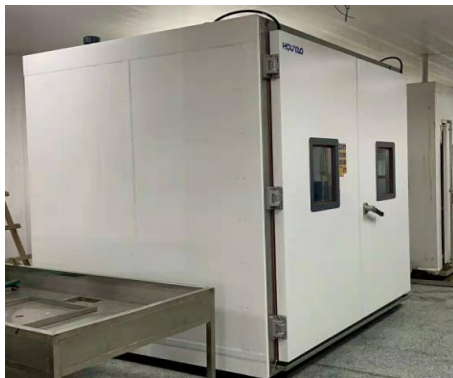
3.1 Damp & heat aging test instrument:

Instrument Name: Damp & Heat Testing Chambers
Instrument manufacturer: Shanghai Houyao
Model: HY-BRS-DH-9

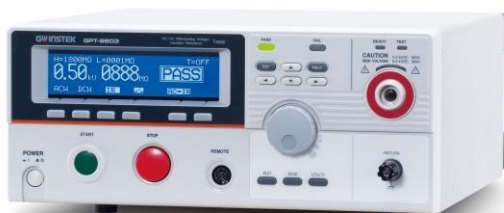
3.2 Wet Leakage test instrument:

Instrument Name: Electrical Safety Tester
Instrument manufacturer: Good Will Instrument Co., Ltd
Model: GEO925909

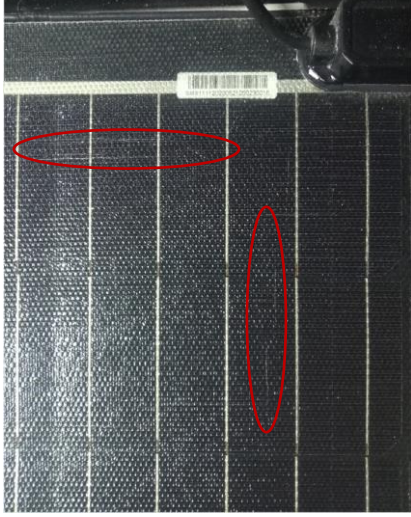
Normal

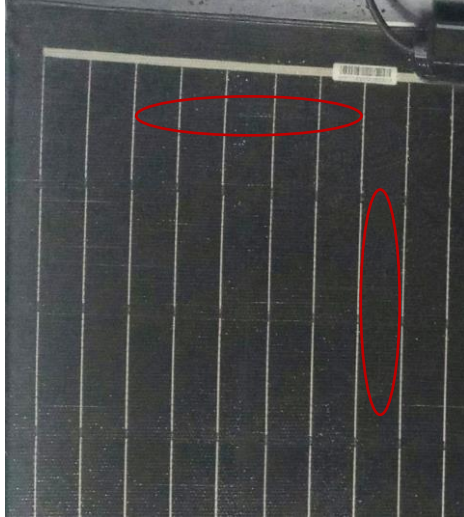
Color: Normal No obvious abnormalities on the creases area	Pass

After DH1000h, the power degradation is less than 5%, and no obvious abnormalities on the creases area, the power and wet leakage tests both meet the requirements;

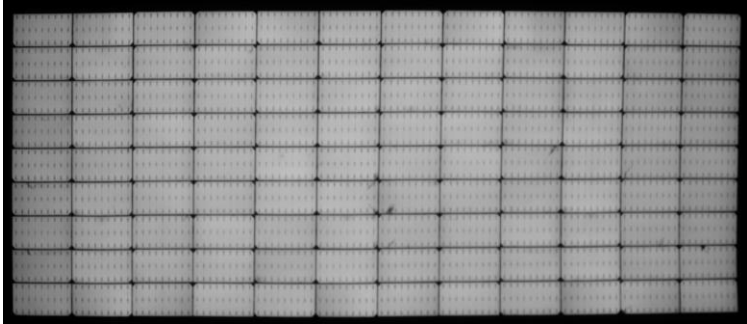
Normal	Pass

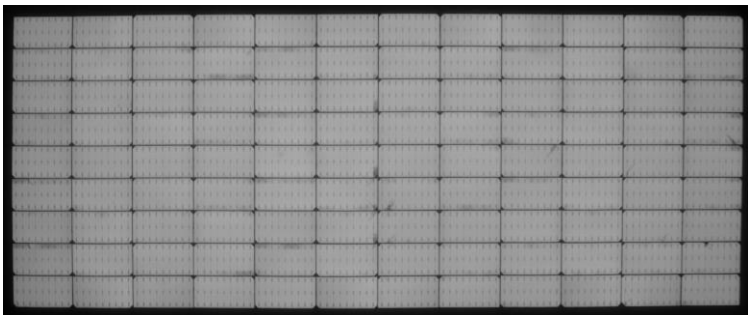
1*IEC

No abnormalities	Pass
--	-------	--	------------------	------

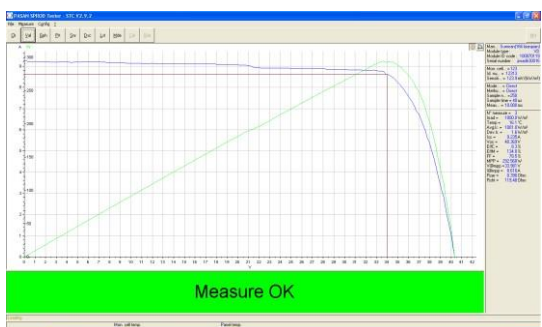
Power: 292.568W	Pass
	1* IEC

No.	Test period	VOC (V)	Vmp (V)	Isc (A)	Imp (A)	Pmp (W)	RS (Ω)	FF (%)	Degradation
1	Before testing	40.369	33.981	9.235	8.610	292.568	0.39	78.5	/
	1* IEC	39.780	33.330	9.336	8.534	284.446	0.41	76.6	2.78%

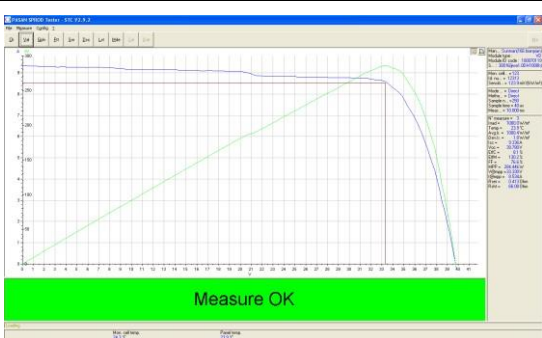
Power: 284.446W Degradation : -2.78%	Pass
